## **HADRIAN'S WALL:**

### **SOME ASPECTS OF ITS POST-ROMAN INFLUENCE ON THE LANDSCAPE.**

ALAN MICHAEL WHITWORTH.

UNIVERSITY OF DURHAM

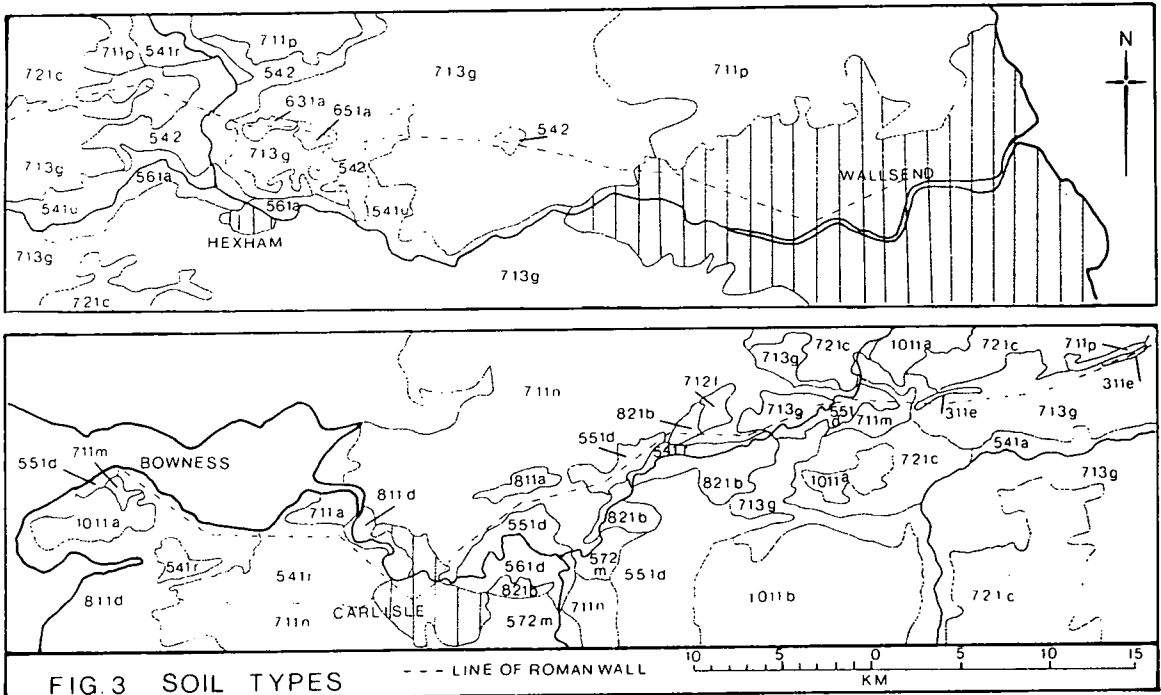
FIG. 3 SOIL TYPES

561a	RIVER ALLUVIUM.	DEEP STONELESS PERMEABLE FINE LOAMY SOILS.FLAT LAND.RISK OF FLOODING. ARABLE WHERE FLOOD RISK LOW; STOCK REARING ON PERMANENT GRASSLAND.	511a	RIVER ALLUVIUM.	DEEP STONELESS FINE LOAMY & CLAYEY SOILS VARIABLY AFFECTED BY GROUND- WATER. FLAT LAND. RISK OF FLOODING. PERMANENT GRASSLAND WITH STOCK REARING & DAIRYING.
572m	REDDISH TILL & GLACIOFLUVIAL DRIFT.	DEEP REDDISH & FINE LOAMY SOILS WITH SLOWLY PERMEABLE SUBSOILS & SLIGHT SEASONAL WATERLOGGING.ARABLE & SOME SHORT TERM GRASSLAND.	811d	MARINE ALLUVIUM.	DEEP STONELESS SILTY & FINE SANDY SOILS VARIABLY AFFECTED BY GROUND- WATER DEPENDING ON ARTIFICIAL DRAINAGE. FLAT LAND.CEREALS & PERMANENT & SHORT TERM GRASSLAND IN CUMBRIA.
631a	PALAEOZOIC & MESO- ZOIC SANDSTONE.	WELL DRAINED VERY ACID COARSE LOAMY SOILS OVER SANDSTONE. WITH A BLEACHED SUBSURFACE HORIZON. POOR GRAZING VALUE.	821b	GLACIOFLUVIAL DRIFT.	DEEP PERMEABLE SANDY & COARSE LOAMY SOILS.CEREALS,ARABLE,SOME GRASSLAND

651a	CARBONIFEROUS & JURASSIC SANDSTONE.	COARSE LOAMY VERY ACID UPLAND SOILS OVER ROCK WITH A WET PEATY SURFACE HORIZON.BARE ROCK & CRAG LOCALLY. POOR GRAZING VALUE.	1011a	RAISED BOG PEAT.	THICK VERY ACID PEAT SOILS.LARGELY UNDRAINED & PERENNIALLY WET. LOW GRAZING VALUE.
			1011b	BLANKET PEAT.	THICK VERY ACID RAW PEAT SOILS. PERENNIALLY WET. POOR GRAZING VALUE

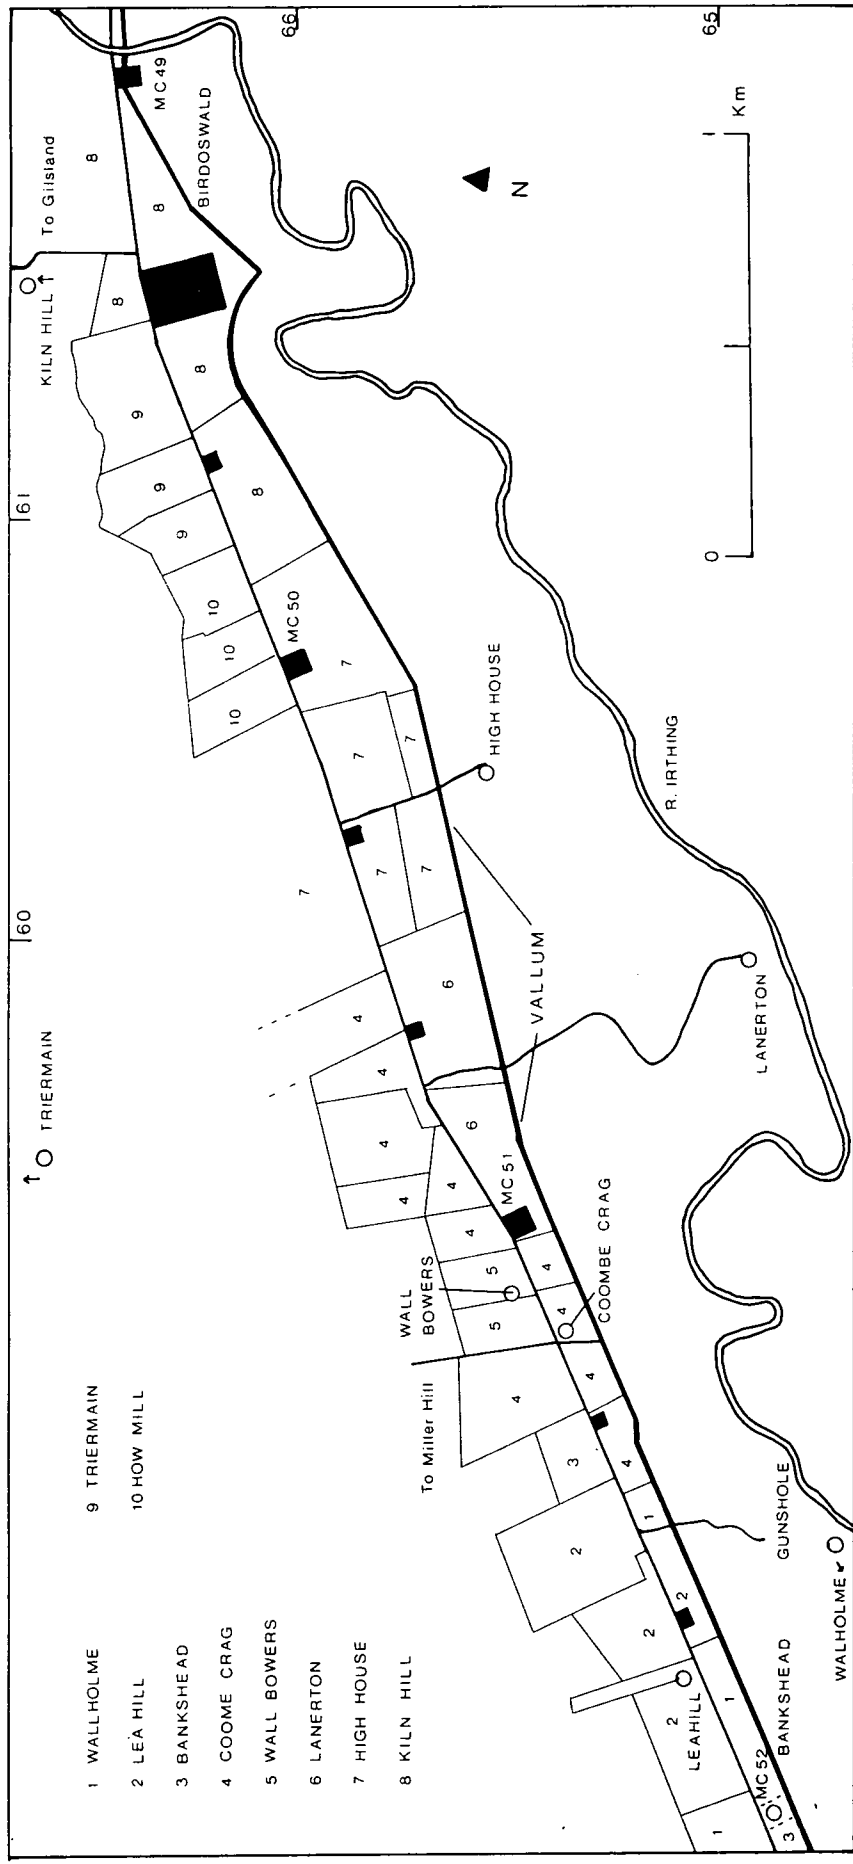
FIG. 4 ROMAN WALL USED AS FARM BOUNDARY: CUMBRIA 1992

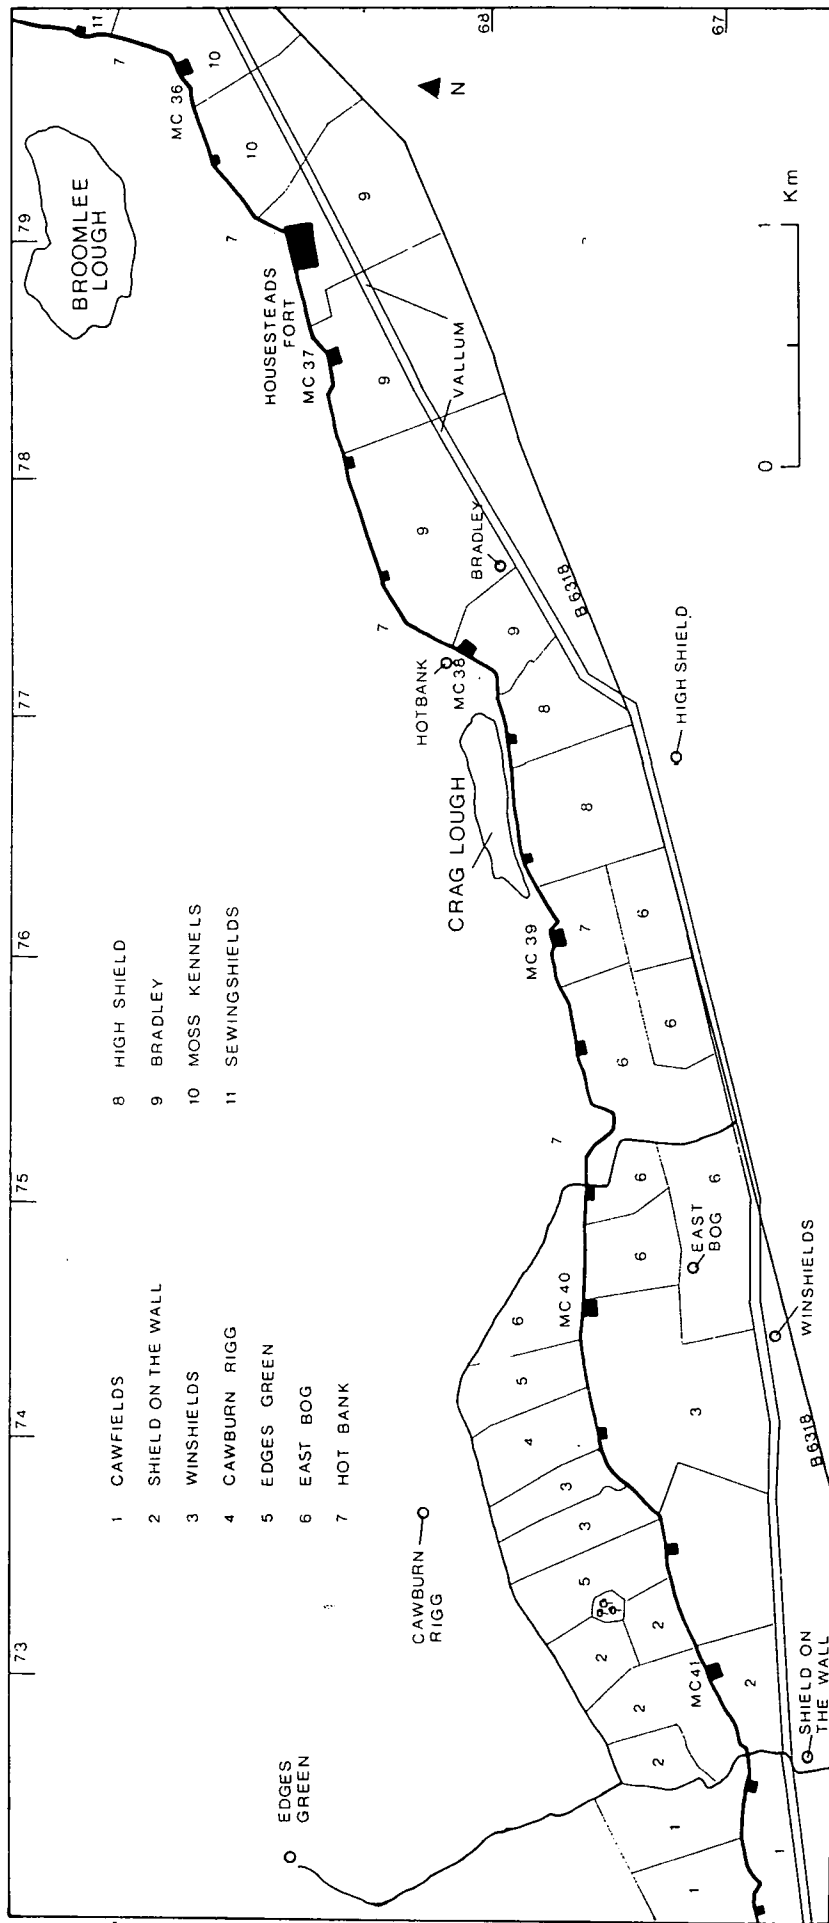
FIG. 5 ROMAN WALL USED AS FARM BOUNDARY: NORTHUMBRIA 1992

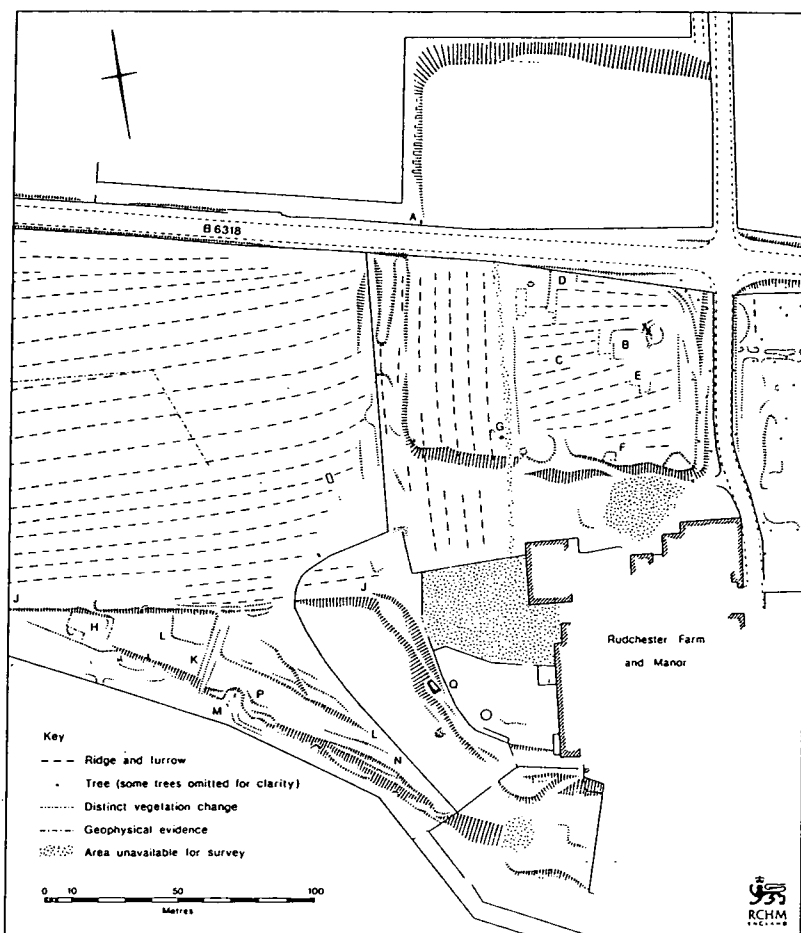
FIG 6 Rudchester Fort showing medieval ploughing and line of Military Road.

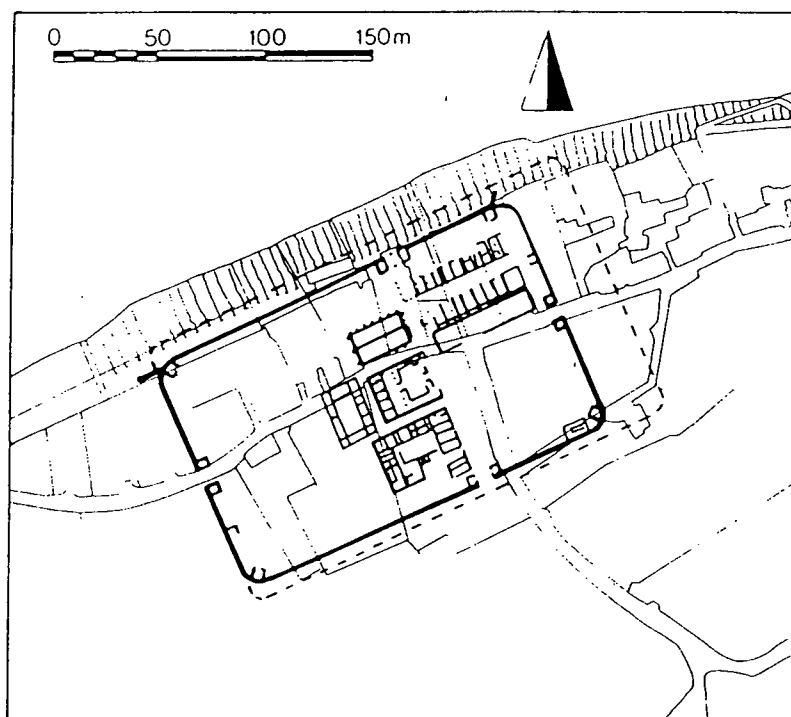
FIG 7 The visible buildings and defences of the fort at Housesteads superimposed over the village of Bowness-on-Solway (solid lines). The 7-acre outline of the fort at Bowness, based on MacLaughlan with revision by Birley, is shown as a dotted line.

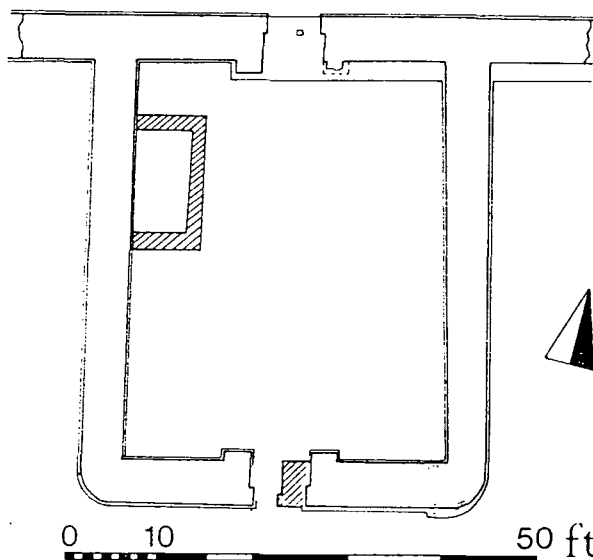
FIG 14 Castle Nick Milecastle, 39. Later walls shaded

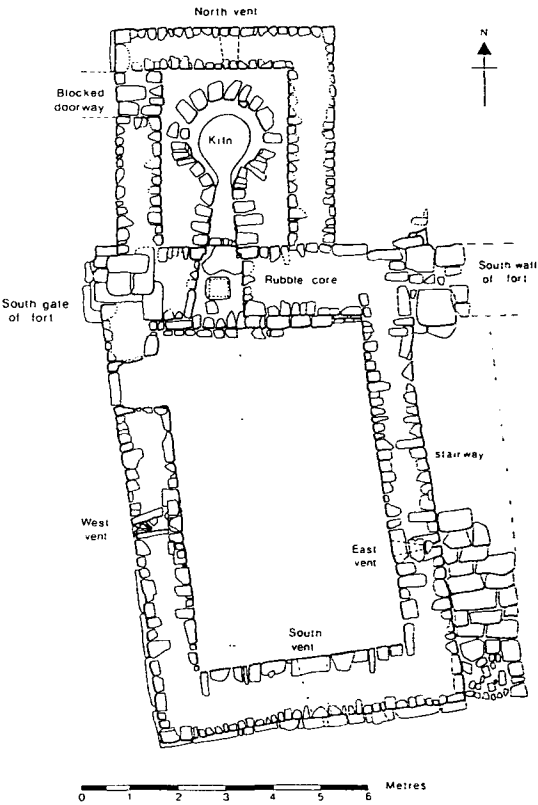
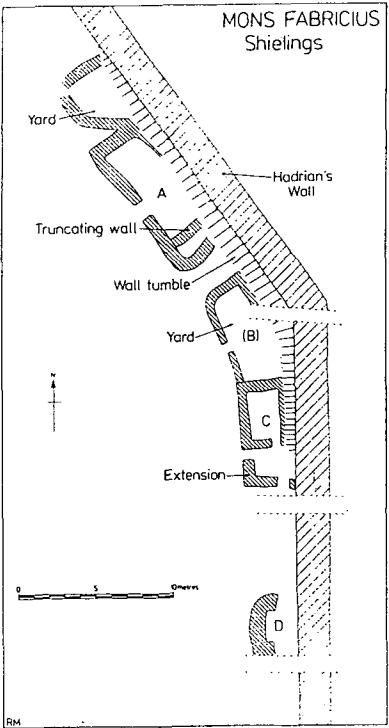
FIG 19 CASTLE NICK, NORTHUMBERLAND  
Shielings constructed against Hadrian's Wall

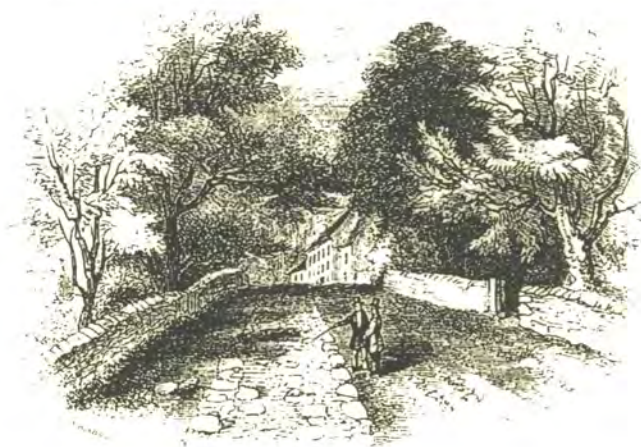
FIG 22 Hadrian's Wall exposed in the road surface at Walwick Bank, near Chesters; the construction of General Wade's military road in the years following 1745 made use of the broad foundation of the Wall for about the first 30 miles (50 km) or so out of Newcastle. In places, as this engraving shows, the foundations of the Wall were still visible within the road surface, and doubtless still survive beneath the modern tarmac.

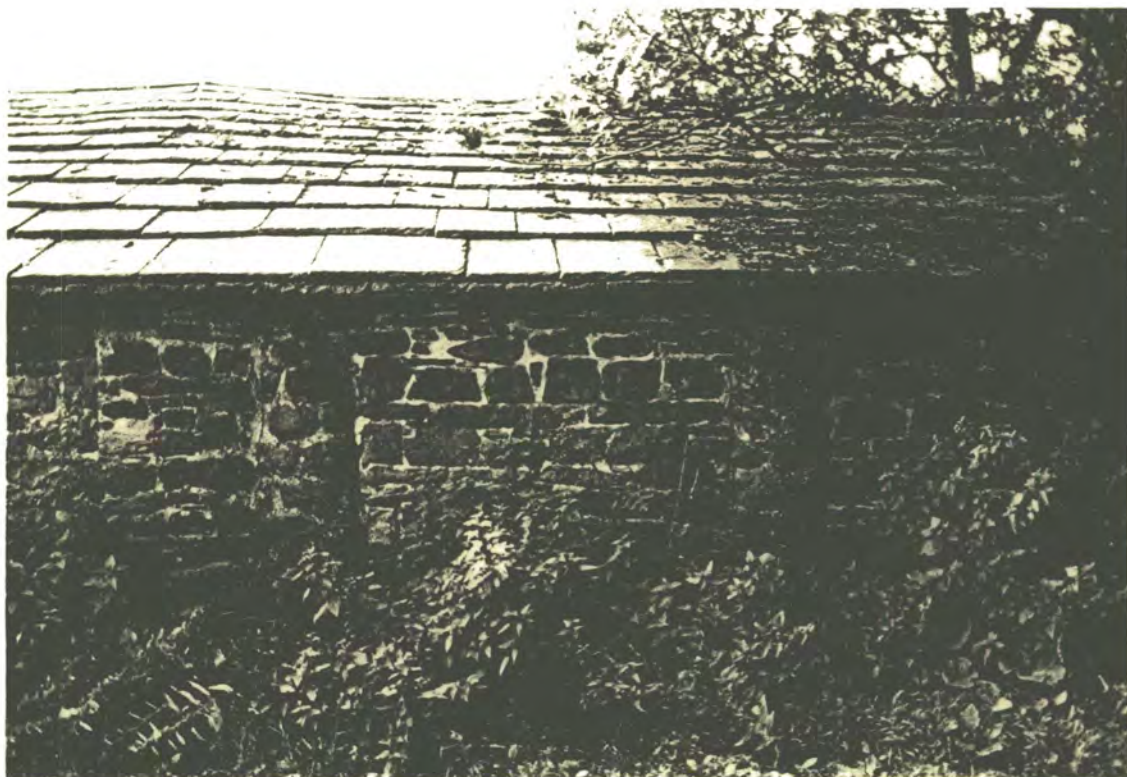
FIG 33 Wall width built into farm at Holmhead

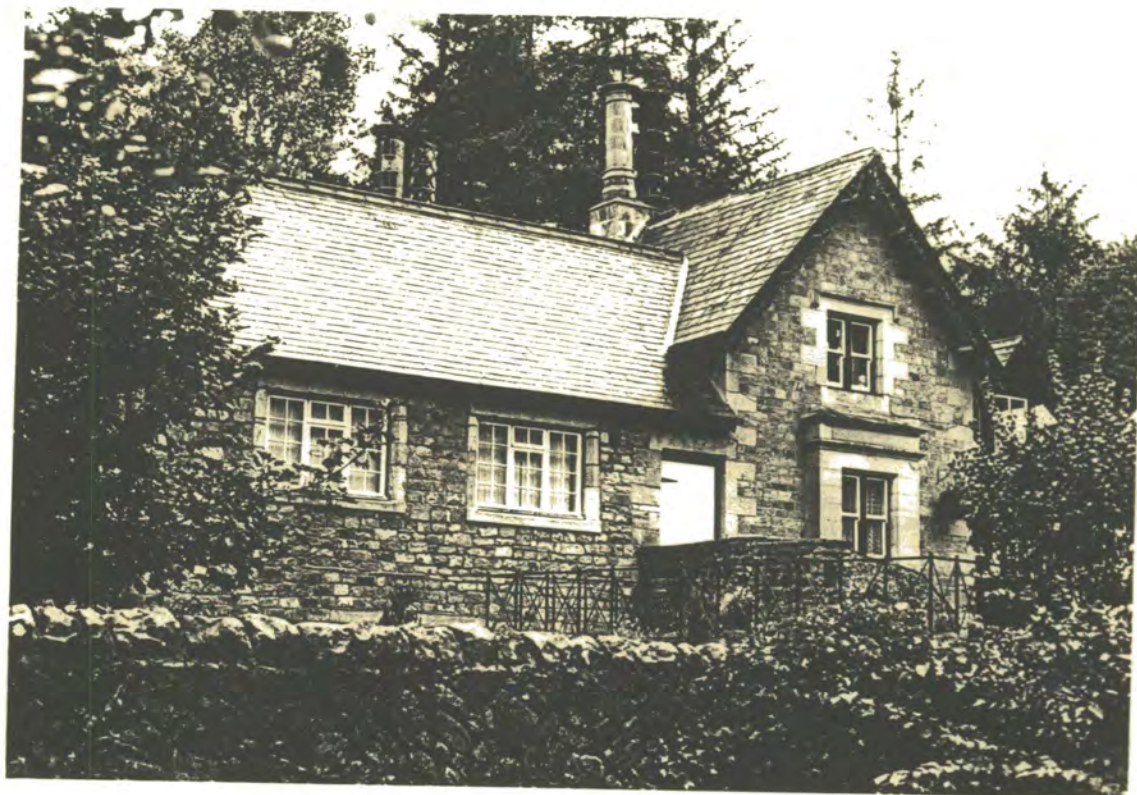
FIG 37 Chesterholme cottage (Vindolanda) built of re-dressed Roman stone

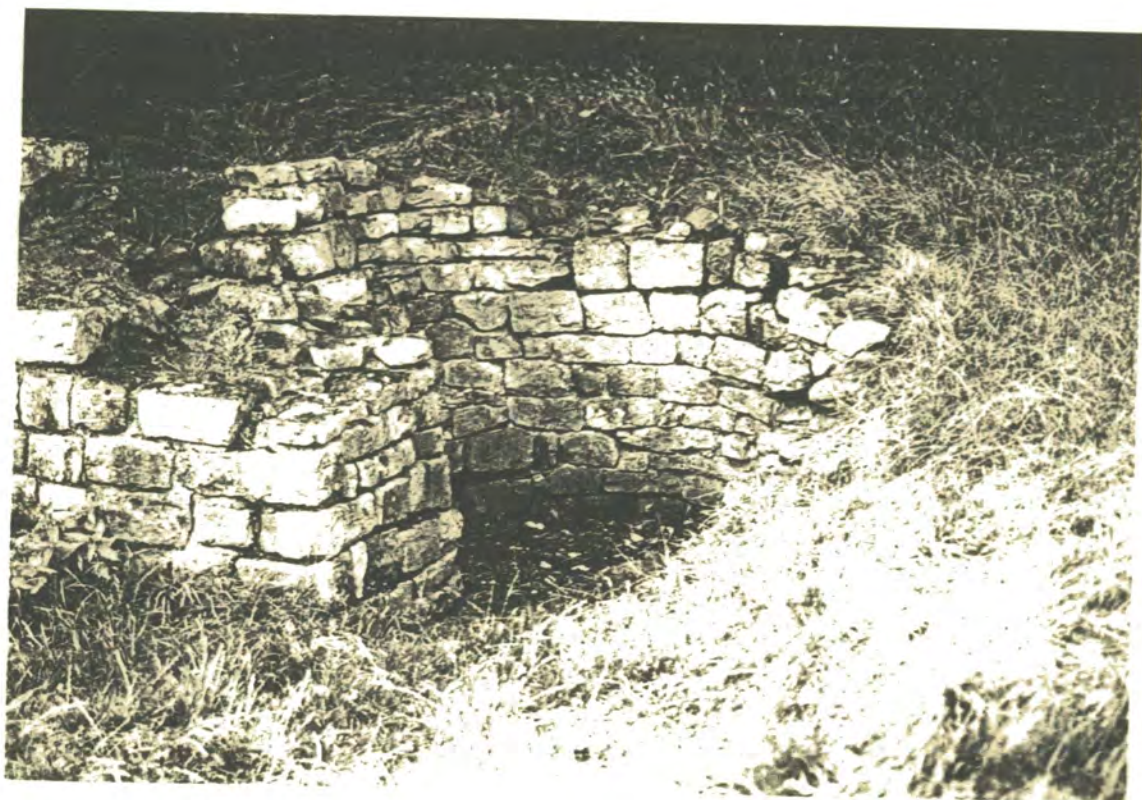
FIG 53 Post-Roman kiln in east wall of Birdoswald fort.

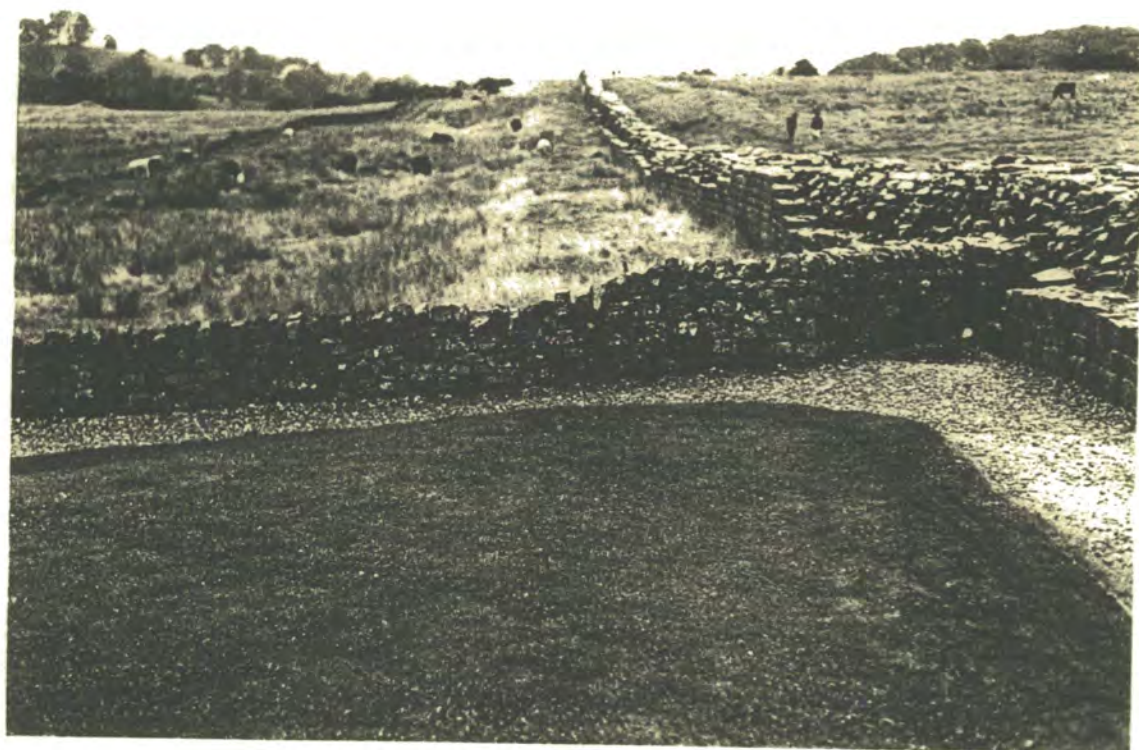
FIG 54 Field wall adjacent to Roman Wall using Wall stone, Birdoswald
